Home Inspection Report

Somewhere
Cleveland, Ohio

Sample Picture Report.alb5

10:16 July 16, 2009

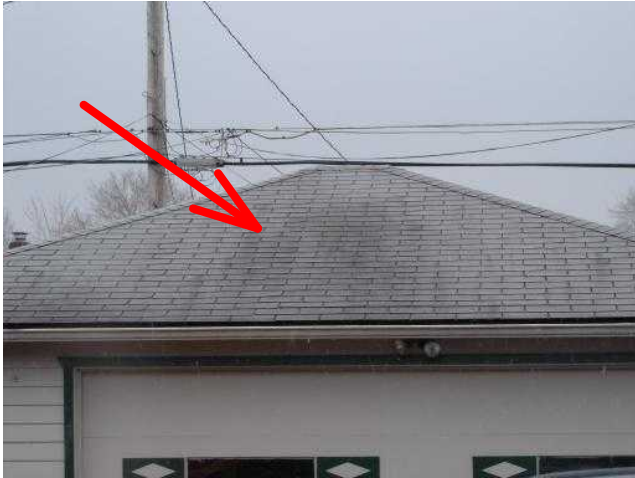
Curling and Cupping Shingles

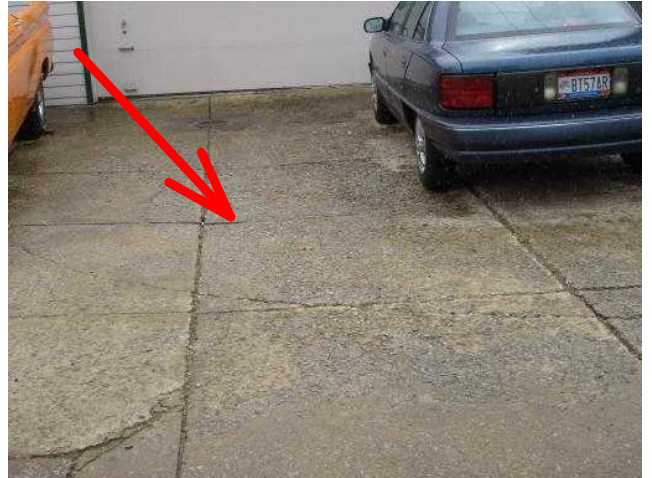
Concrete in driveway needs repaired

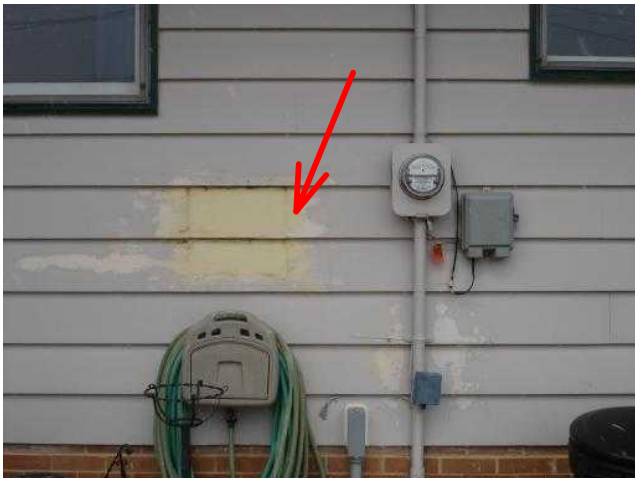
Recommend painting

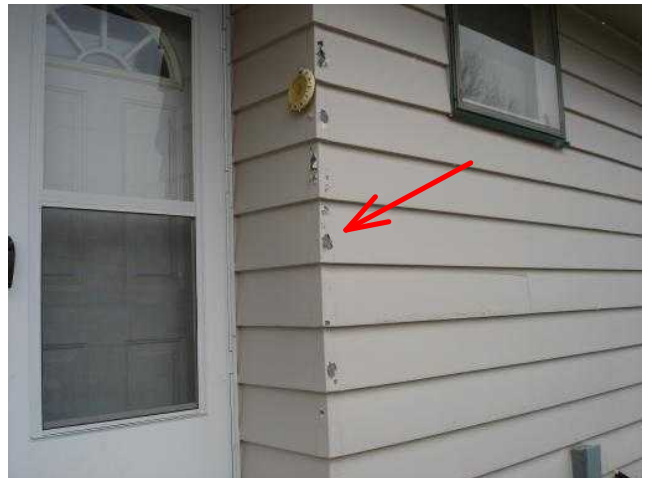
Paint peeling

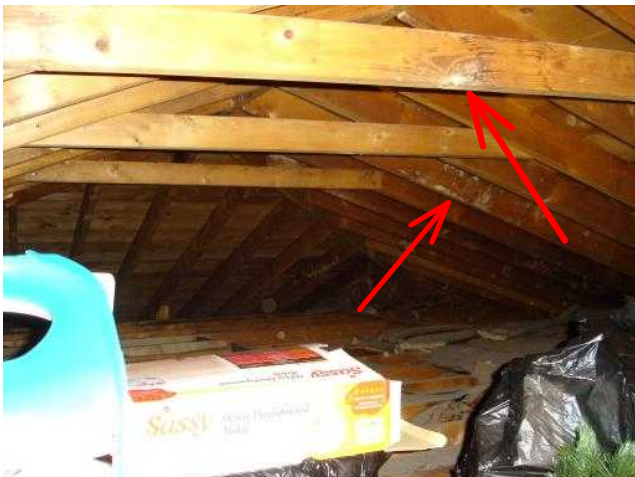
Possible visible mold

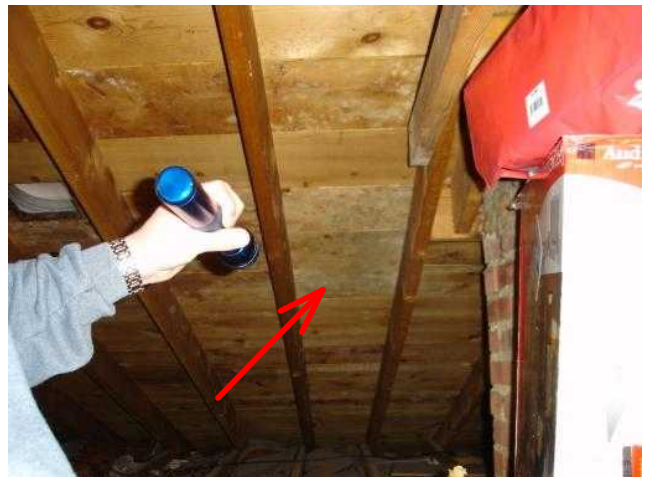
Possible visible mold

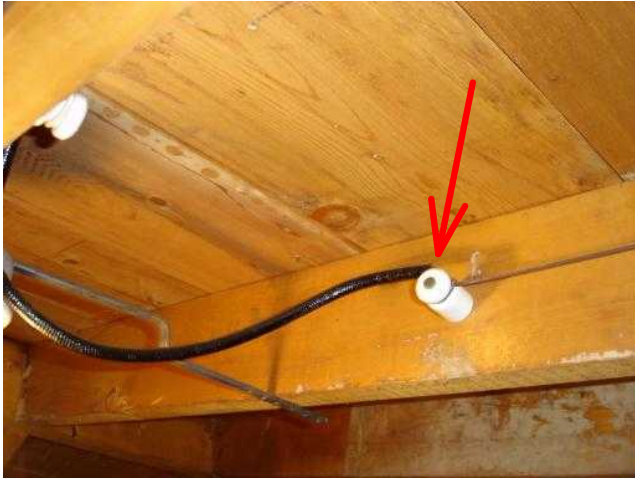
Knob and tube wiring

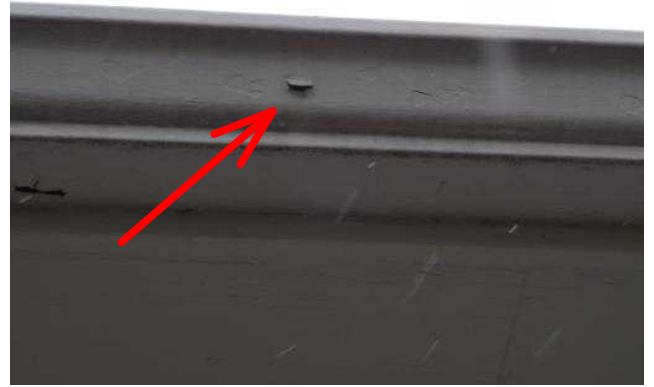
Paint Peeling

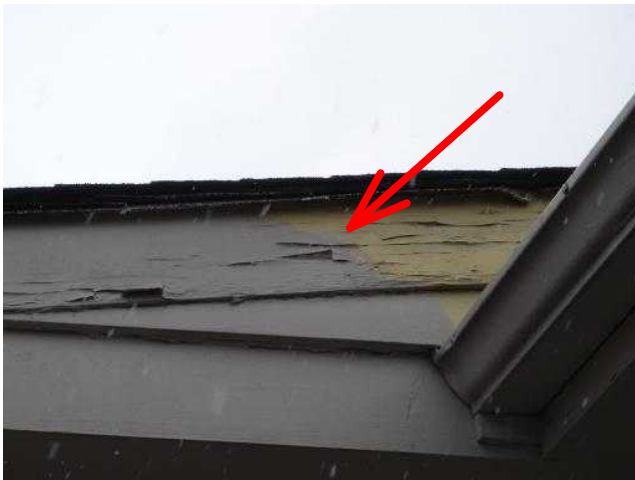
Paint Peeling

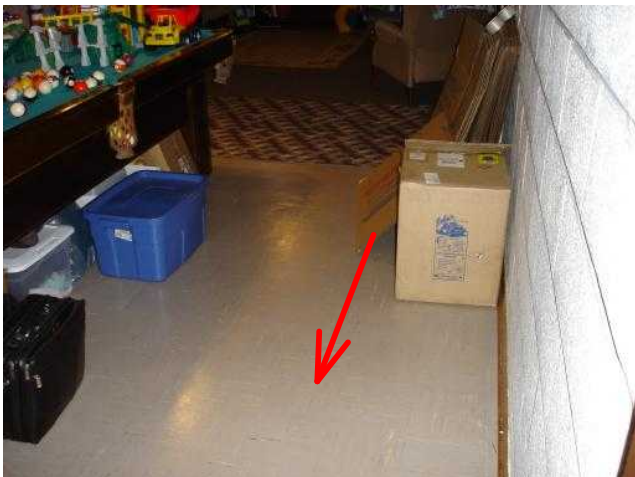
Possible Asbestos floor tiles

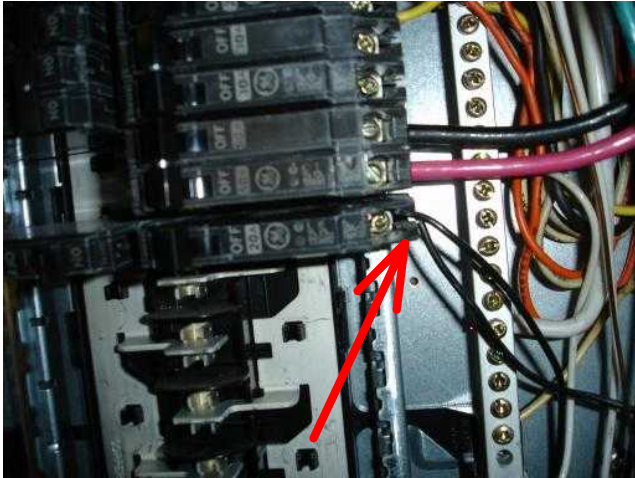
Double tap in the electric panel

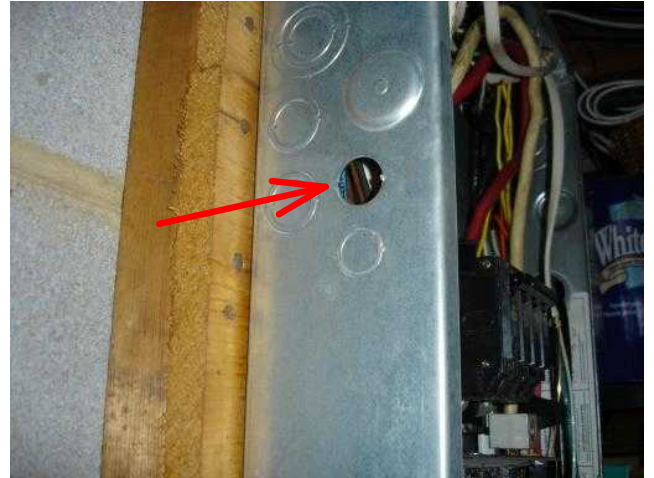
Knockout needs to be sealed

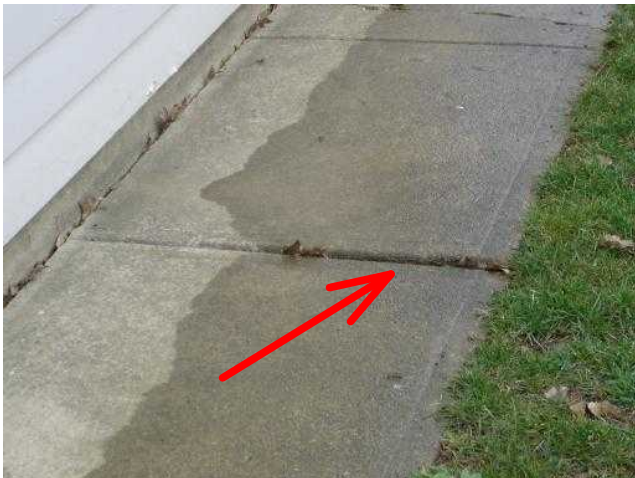
Trip Hazard

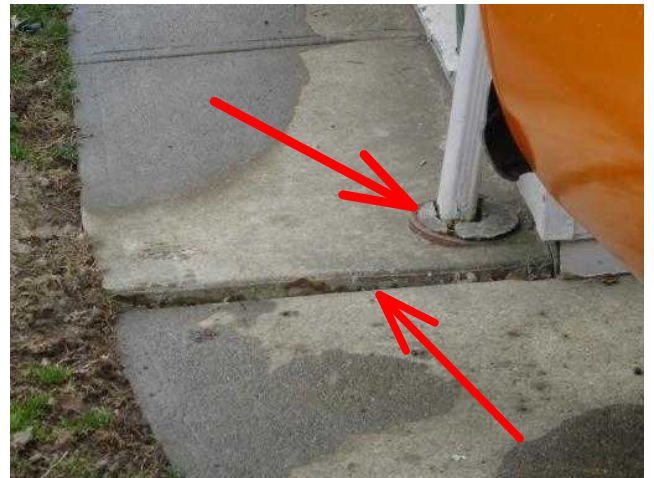
Trip hazard and downspout need to be resealed

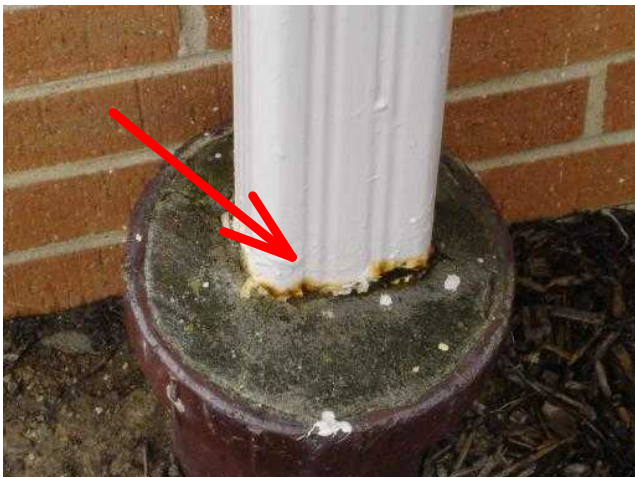
Downspout rusting

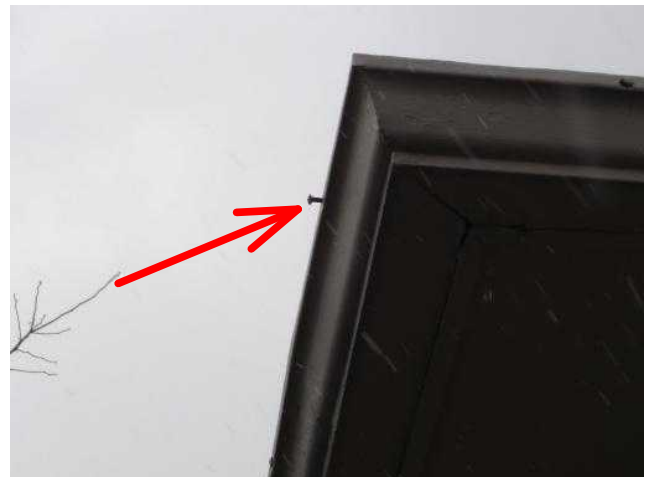
Nails coming out of the gutters
